Monitoring Data Record

Project Title: B-3126 (Br. #90 over Gunpowder Creek on SR 1718
 COE Action ID: 2007-1591-214 DWQ Number: 070583
 Stream Name: Tributary to Gunpowder Creek
 City, County and other Location Information: Caldwell County, Bridge #90 over
Gunpowder Creek on SR 1718(Deal Mill Road) near Granite Falls..
 Date Construction Completed: 3/11/09 Monitoring Year: (2) of 5
 Ecoregion: 8 digit HUC unit 03050101
 USGS Quad Name and Coordinates: Granite Falls N 35.84415, W 81.43603

Tributary to Gunpowder Creek

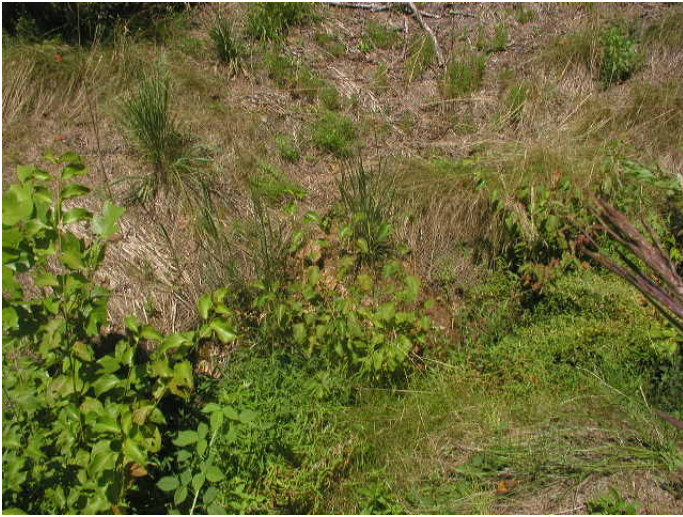
Date 7/22/2010	Sta. 0+90 -NSD-	Sta. 2+40 -NSD-	Sta. 2+50 -NSD-	Station Number	Station Number
Structure Type		Crossvane	Crossvane		
Is water piping through or around structure?		Water piping under crossvane due to low water flow	Water piping under crossvane due to low water flow		
Head cut or down cut present?					
Bank or scour erosion present?	Minor bank scouring on right bank				
Other problems noted?

Minor bank scouring along right bank @ Sta. 0+90
